**Flood Control Project Maintenance
Levee Inspections**
LMA District Cover Sheet
Spring 2017 Levee Inspection Results

Levee District No. 0009 (Sutter County)

Spring 2017 Levee Inspection Results

Waterway			Bank	Unit Miles
Unit No. 01 Sutter County, Feather River			Right	6.25
	Spring (March - May)	Summer (June - August)	(September - November) Fall	Winter (December - February)
Unit Maintenance Rating (Fall Only)				
Date of Inspection	4/19/2017 - 4/19/2017			
DWR Inspector	Sterling York			
Accompanied By	David Schmidl

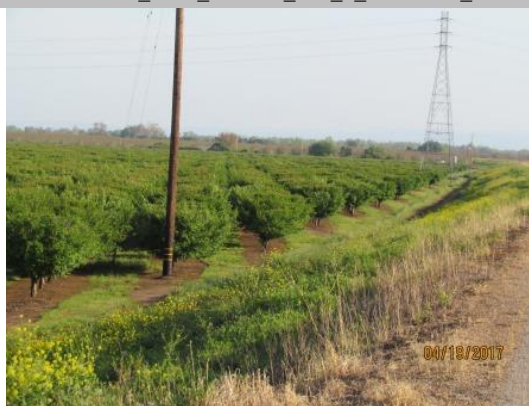
Photo 1 of 1 : SP_2017_LD0009_202_1_20170426_00006.jpg

LM Start	0.02	Rating **	M	Issue No.	1
LM End	6.25	Issue Type +	Ma	Location *	LS
Category	Earthen Levee			GPS Latitude/Longitude	
				Start	End
Item	Vegetation			39.169117 °	39.255839 °
				-121.622620 °	-121.636402 °
DWR ID	DWR_LD0009_01_s_2017_1				
Comment Code					
V1 : Control annual grass and weeds on the levee slopes and easements.					
Inspector Comment					
Annual grasses need to be maintained, Spring 2017.

View looking upstream of annual grasses that need to be maintained, Spring 2017.

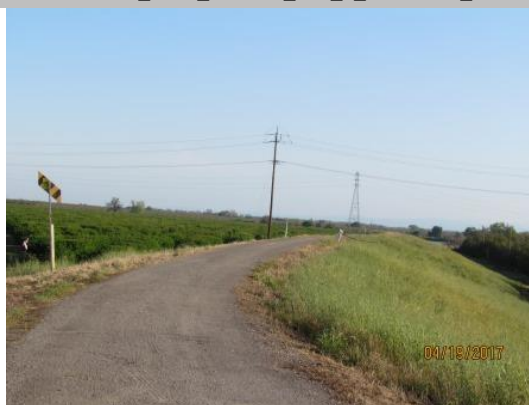
Photo 1 of 1 : SP_2017_LD0009_202_2_20170426_00007.jpg

LM Start	0.02	Rating **	M	Issue No.	2
LM End	6.25	Issue Type +	Ma	Location *	WS
Category	Earthen Levee			GPS Latitude/Longitude	
				Start	End
Item	Vegetation			39.169117 °	39.255839 °
				-121.622620 °	-121.636402 °
DWR ID	DWR_LD0009_01_s_2017_2				
Comment Code					
V1 : Control annual grass and weeds on the levee slopes and easements.					
Inspector Comment					
Annual grasses need to be maintained, Spring 2017.

View looking downstream of annual grasses that need to be maintained, Spring 2017.

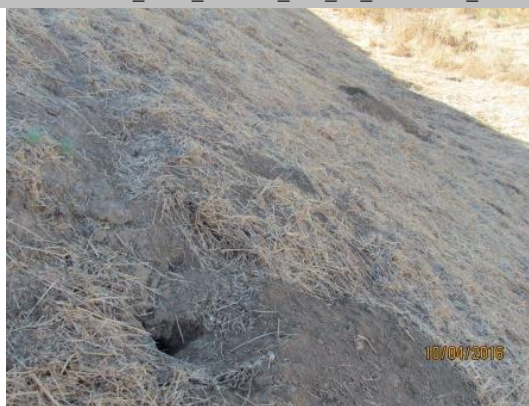
Photo 1 of 1 : SP_2017_LD0009_202_18_20170316_00003.jpg

LM Start	0.09	Rating **	A/W	Issue No.	18
LM End	0.09	Issue Type +	Ma	Location *	LS
Category	Earthen Levee			GPS Latitude/Longitude	
				Start	End
Item	Animal Control			39.170064 °	39.170064 °
				-121.622563 °	-121.622563 °
DWR ID	DWR_LD0009_01_f_2016_18				
Comment Code					
A3 : No rodents visible, but rodent burrows visible; need to backfill and compact or grout burrows.					
Inspector Comment					
No animal activity. Rodent holes need to be backfilled. Spring 2017.

View of rodent holes that need to be backfilled, no sign of rodents at time of inspection. Fall 2016.

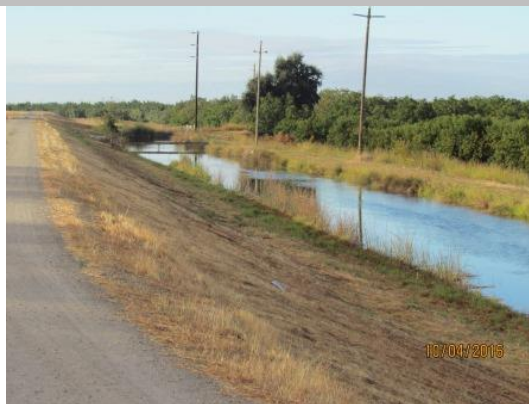
Photo 1 of 1 : SP_2017_LD0009_202_20_20170316_00005.jpg

LM Start	5.66	Rating **	M	Issue No.	20
LM End	6.00	Issue Type +	En	Location *	LS
Category	Earthen Levee			GPS Latitude/Longitude	
				Start	End
Item	Encroachments			39.247349 °	39.252258 °
				-121.637341 °	-121.637077 °
DWR ID	DWR_LD0009_01_f_2016_20				
Comment Code					
DT : Ditch					
Inspector Comment

View of ditch at the toe of the landside, looking downstream.

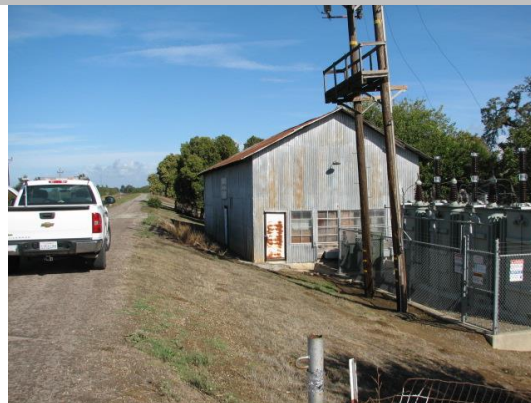
Photo 1 of 2 : SP_2017_LD0009_202_11_20170316_00001.jpg

LM Start	5.68	Rating **	M	Issue No.	11
LM End	5.68	Issue Type +	En	Location *	WS
Category	Earthen Levee			GPS Latitude/Longitude	
				Start	End
Item	Encroachments			39.247697 °	39.247697 °
				-121.637312 °	-121.637312 °
DWR ID	DWR_LD0009_01_s_2012_11				
Comment Code					
BU : Building					
Inspector Comment

Building at the waterside toe.

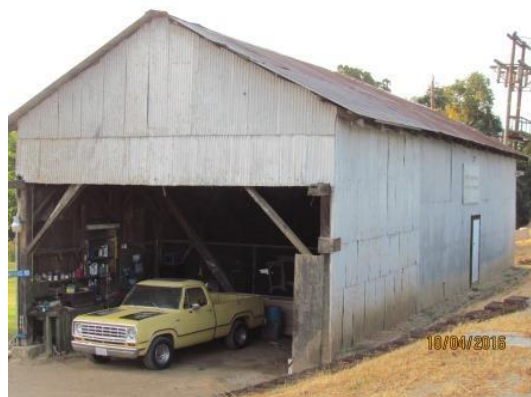
Photo 2 of 2 : SP_2017_LD0009_202_11_20170316_00002.jpg

LM Start	5.68	Rating **	M	Issue No.	11 (cont)
LM End	5.68	Issue Type +	En	Location *	WS

Building at the waterside toe looking downstream.
